INSIGHT ENGINEERING CO.

STORMWATER SITE PLAN

For
Clothier SP

Stormwater Site Plan Preparation Date:
September 29, 2017
Approximate Construction Date:
May 1, 2018

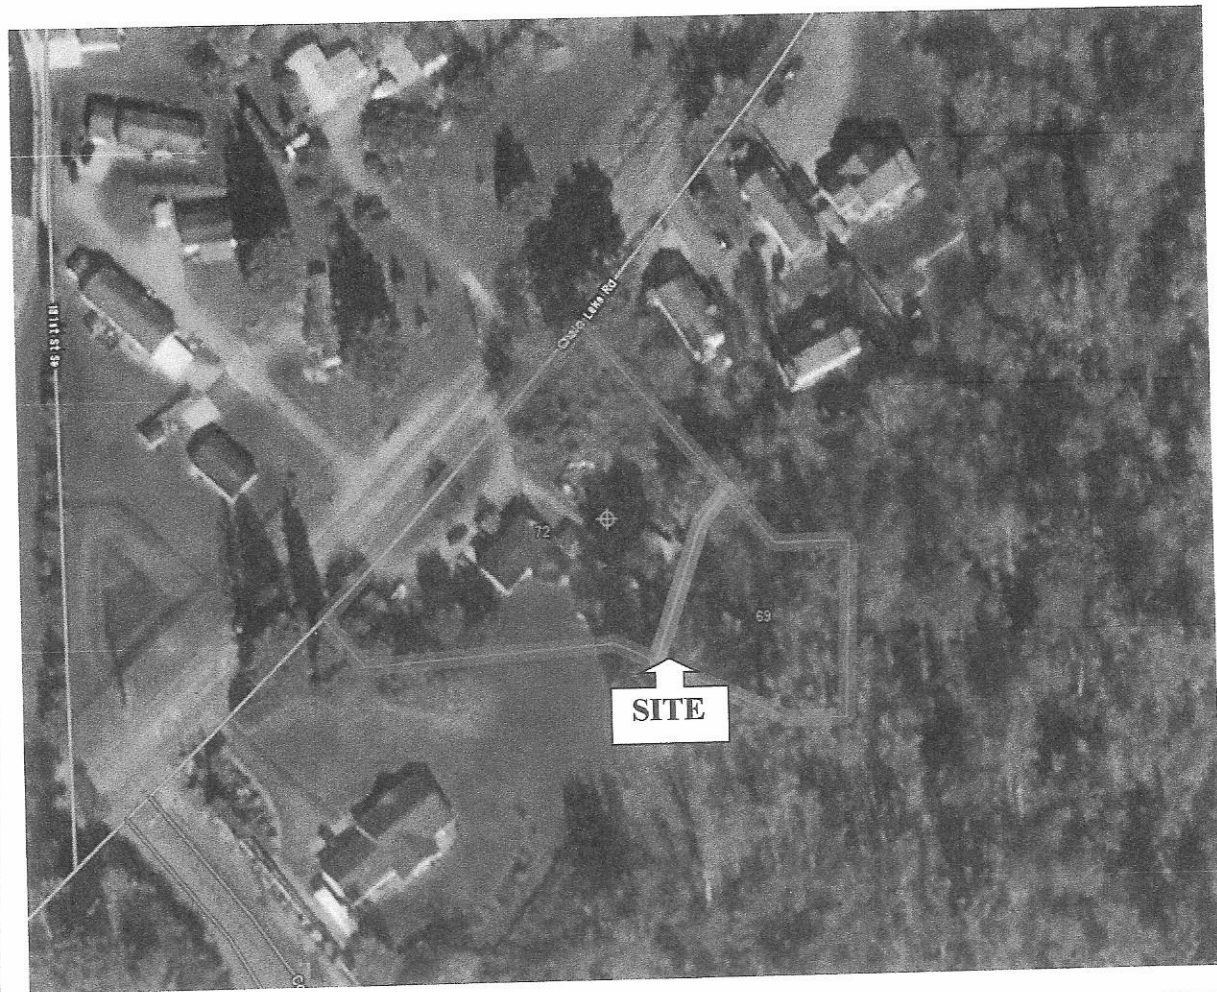
FIGURE 3. SOIL MAP

Figure 3 - Soil Map
Clothier SP
Monroe, Washington

The site is currently developed with a house, a detached shop, a shed and a gravel driveways from Chain Lake Road. There exists some residential landscaping with many fully grown trees. The remaining site is covered with bushes and second growth forest. There is a 100-ft buffer and a delineated wetland exist in the lowland are of the site. This area will be set aside in a NGPA tract for conservation. The site contains one drainage basin that slopes moderately to the south east. Please refer to the downstream analysis map for more details. Per NRCS survey of Snohomish County, the project site contains Tokul soils and Terric Medisaprists soils that have a hydrologic classification of Type "C". Please refer to the soils map and descriptions attached later in this report for more details.

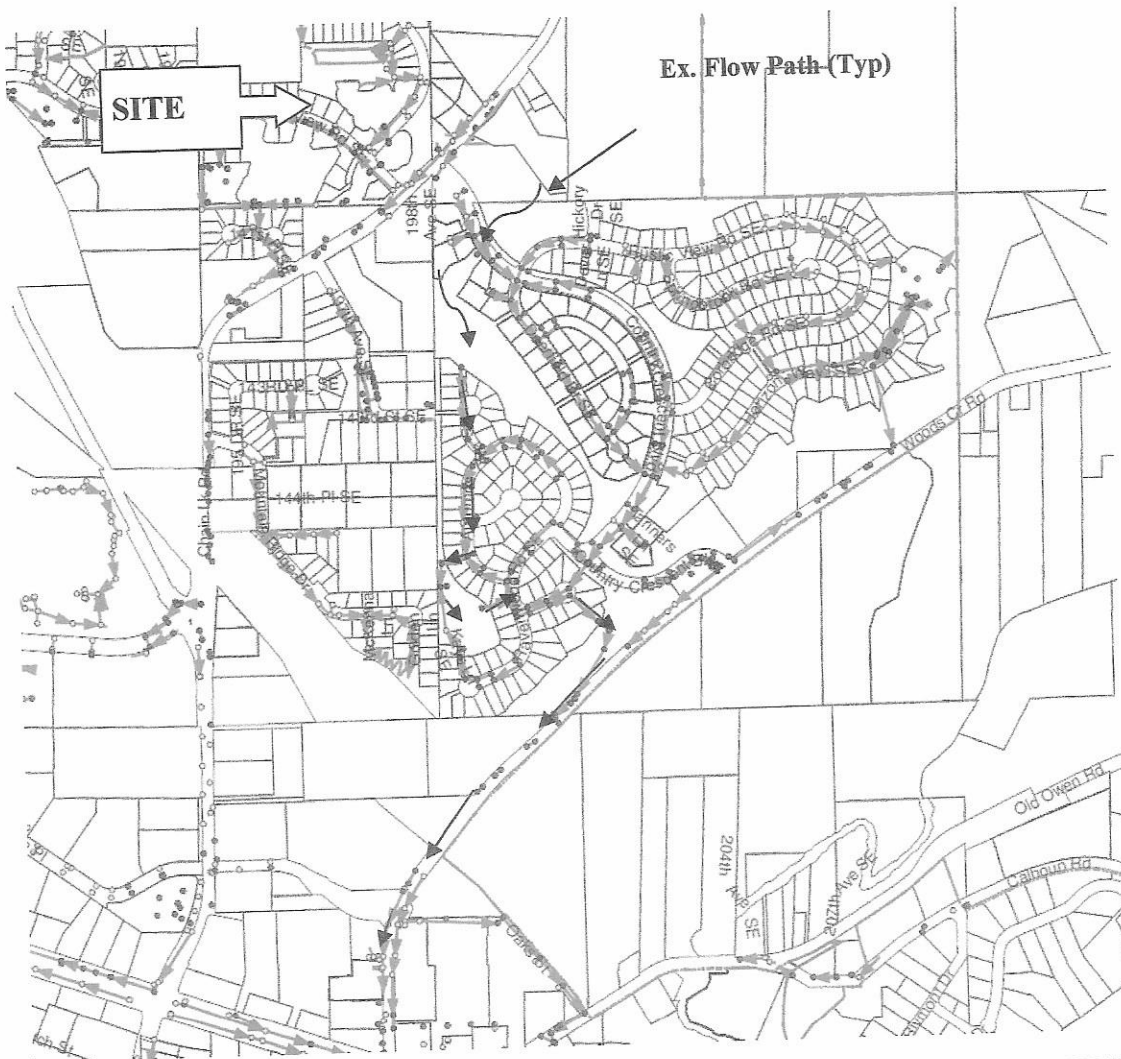
FIGURE 5. DOWNSTREAM ANALYSIS MAP-2

Figure 5 - Downstream Analysis Map-2

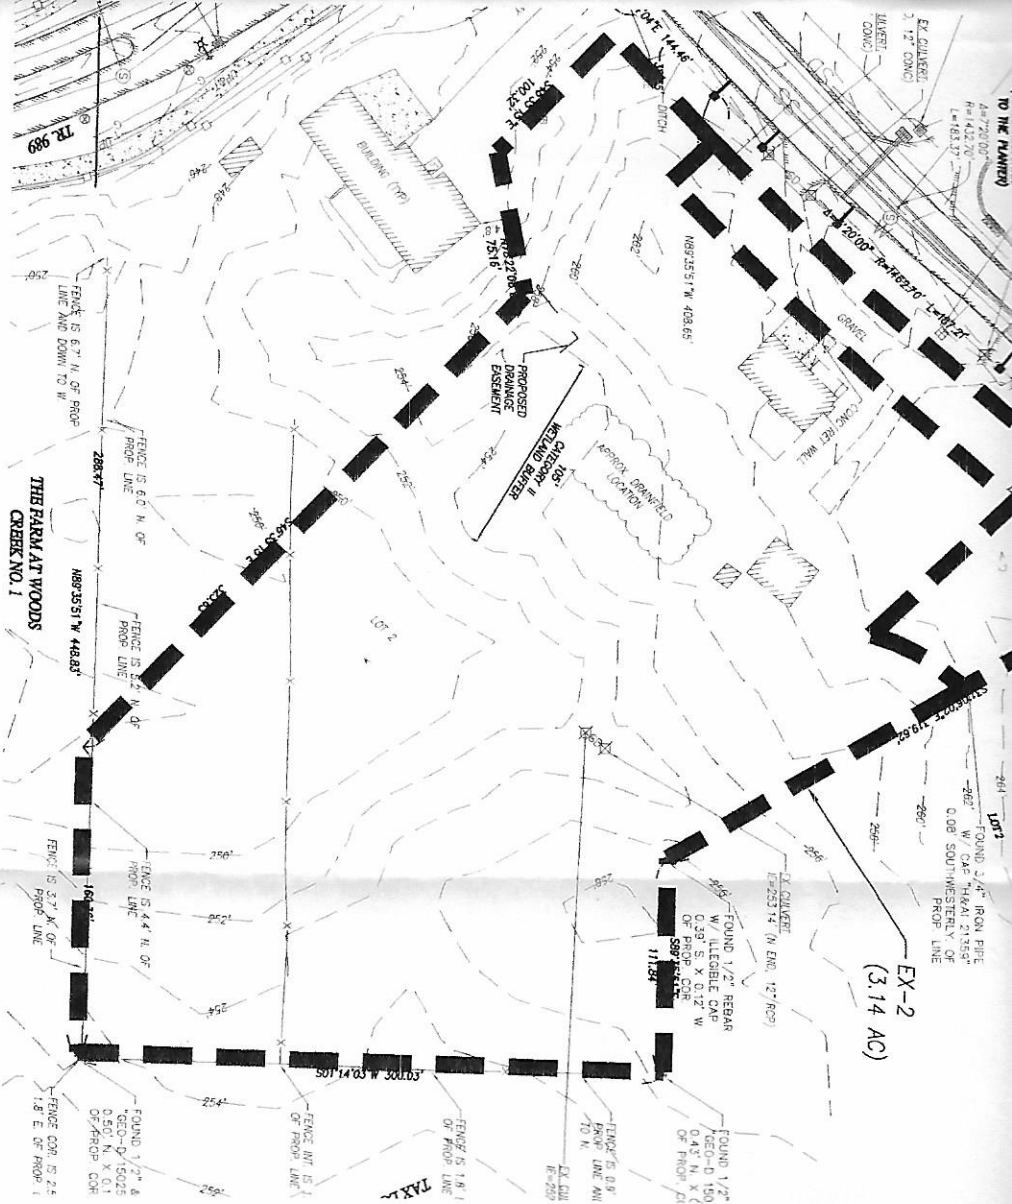
SCALE: 1" = 100'

Refer to the Developed Basin Map and the following pages for more details.

The impervious areas will be directed to pervious asphalt as shown on the plans. Pervious area will be dispersed into the lawn areas and infiltrated.

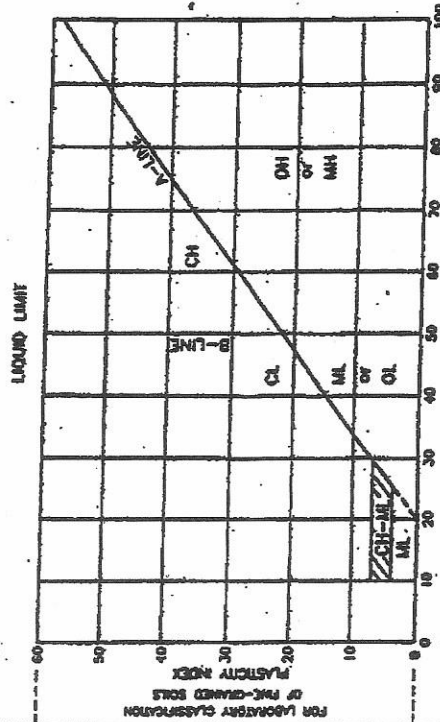
PLASTICITY CHART
